### A Case Study on the Extreme Flood Affected Minmyin Dam

Due to an Extreme Flood, Dam Overtopping Happened on

18 July 2015 but Minmyin Dam was Safe.

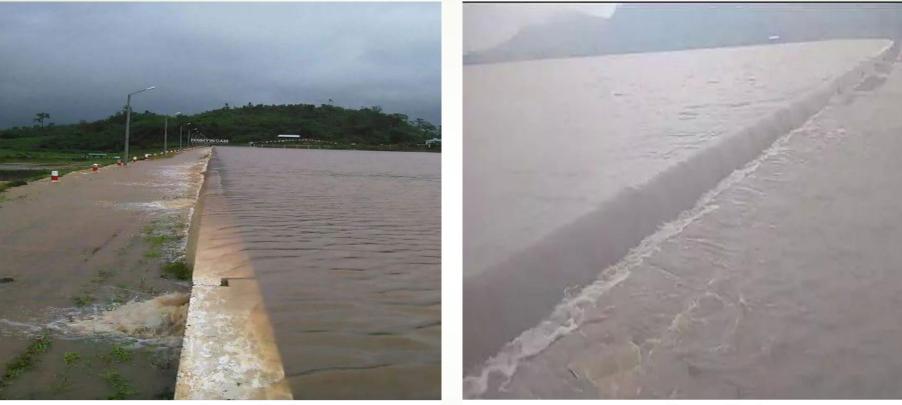
တမံ Parapeteoါ်မှ ရေတျော်စီးဆင်းနေပုံ

Spill over Parapet

တမံ Parapeteol်မှ ရေကျော်စီးဆင်းနေပုံ

Dam Overtopping

Duration of dam overtopping from (08:00 to 13:00) on 18.7.2015 = 5 h Maximum water level recorded on (18.7.2015, 09:20), R.L = 692.3 ft.Flood water level over dam parapet,  $H_2 = 692.3 - 692.0 = 0.3 \text{ ft.}$ Crest of parapet = 692.0 ft.

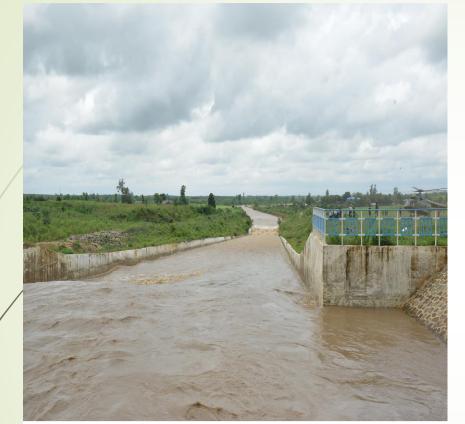
ရေပိုလွှဲမှ ရေကျော်စီးဆင်းနေပုံ

#### Flood Flow over Spillway

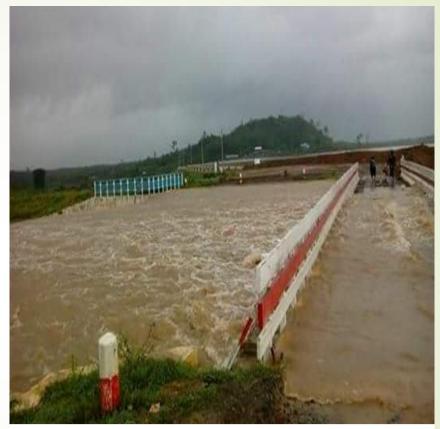
ရေပိုလွှဲတံတားမှ ရေကျော်စီးဆင်းနေပုံ

Submergence of Spillway Bridge

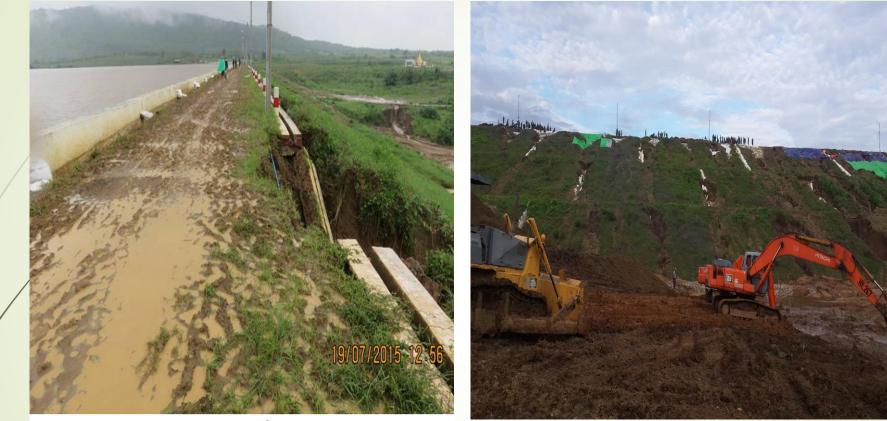
တမံ D/Sအား မြင်တွေ့ရပုံ

#### Dam Crest Erosion

Dam D/S Face Erosion

- Scours at the toe of the parapet,
- Gullies at R.D.800 ft., 1,200 ft. and 1,600 ft. on the dam downstream face,
- (9) nos. of slope drains were damaged,
- Crest drain was damaged at R.D 1,600 ft. and 2,200 ft.,
  - 150 ft. wide slip of dam toe at R.D. 1,200 ft. due to toe drain scour,
- Eroded materials deposited on rock toe,
- No differential settlement was observed,
- No bulging was observed on dam downstream face,
- Spillway under floods seemed in good condition.

- Grass turfing, crest drain, slope drains and thick kankar retarded scouring to some extent, but scouring occurred when flow was concentrated at the end of overtopping,

- Scour at the toe of parapet is due to insufficient compaction in kankar laying,
- Slip at the downstream dam toe must be filled promptly,
- Parapet is excluded in dam height consideration, but 2.0 ft. parapet rendered an absorption of flood in this incident though some leakage from gaps between parapets,

After Flood, all the damage parts were removed and **dam filling** was made on the downstream dam slope.

Dam crest was raised another 5 ft. and made proper protection on the upstream and downstream dam slopes. The downstream dam slope was slightly changed.

In addition, a 300 ft. emergency spillway was provided on the left bank.

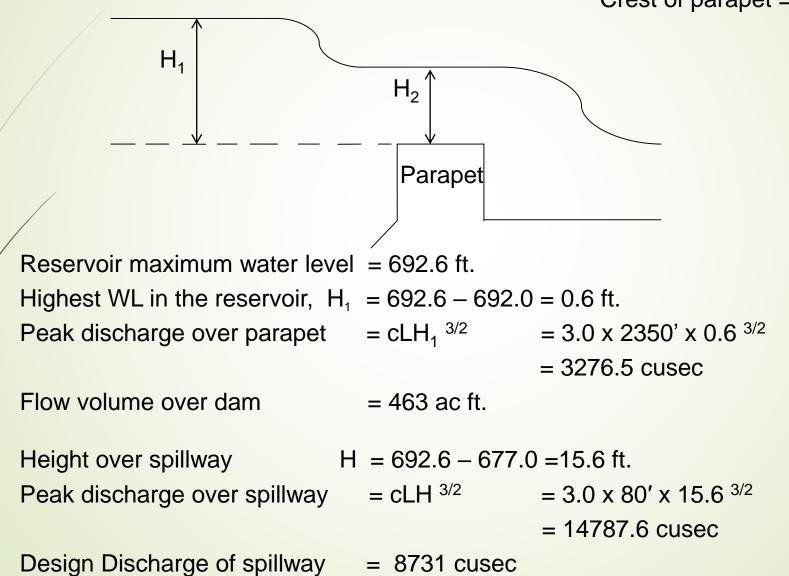
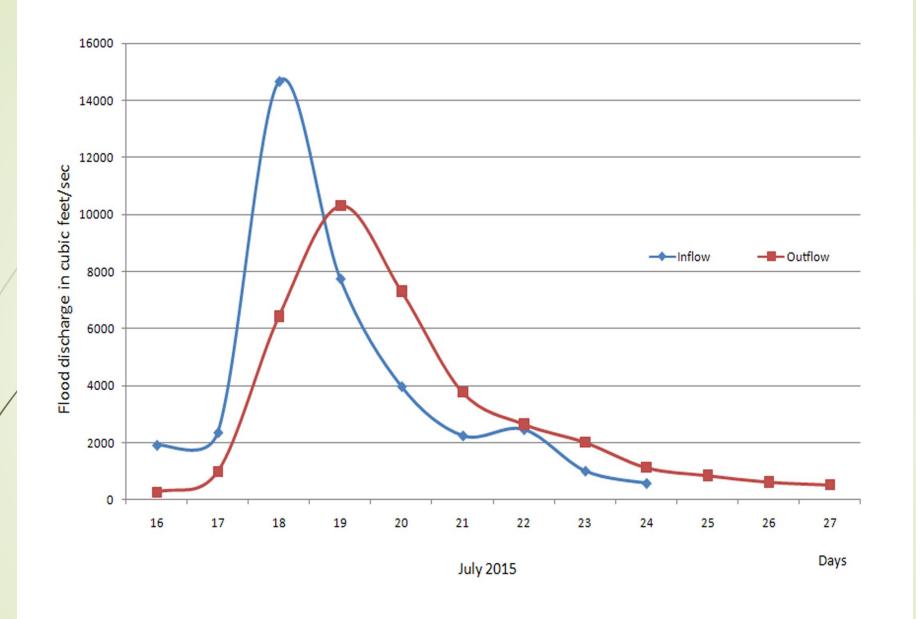
Inflow / Outflow Hydrograph

Routed peak inflow discharge	=	14667.2 cusec
Routed peak outflow discharge	=	10310.2 cusec
Inflow flood volume	=	73,381 ac ft.
Outflow flood volume	=	73,210 ac ft.
Flow volume over dam	=	463 ac ft.

Rate of water level rising on 18.7.2015 (from 02:00, 684.2 ft. to 09:00, 692.0 ft.) = 7.8 ft. / 7 h = 1.1 ft./h

Rate of water level rising is very high probably (1) Steep bed slope of river,

(2) Rainfall closer to dam.
