# GEOTECHNICAL HAZARDS IN MYANMAR

## Lessons from the 2025 Mw 7.7 Mandalay Earthquake

From observed ground failure to resilient ASEAN practice

**Engr. Prof: Dr. Hla Myo Aung, P.E**

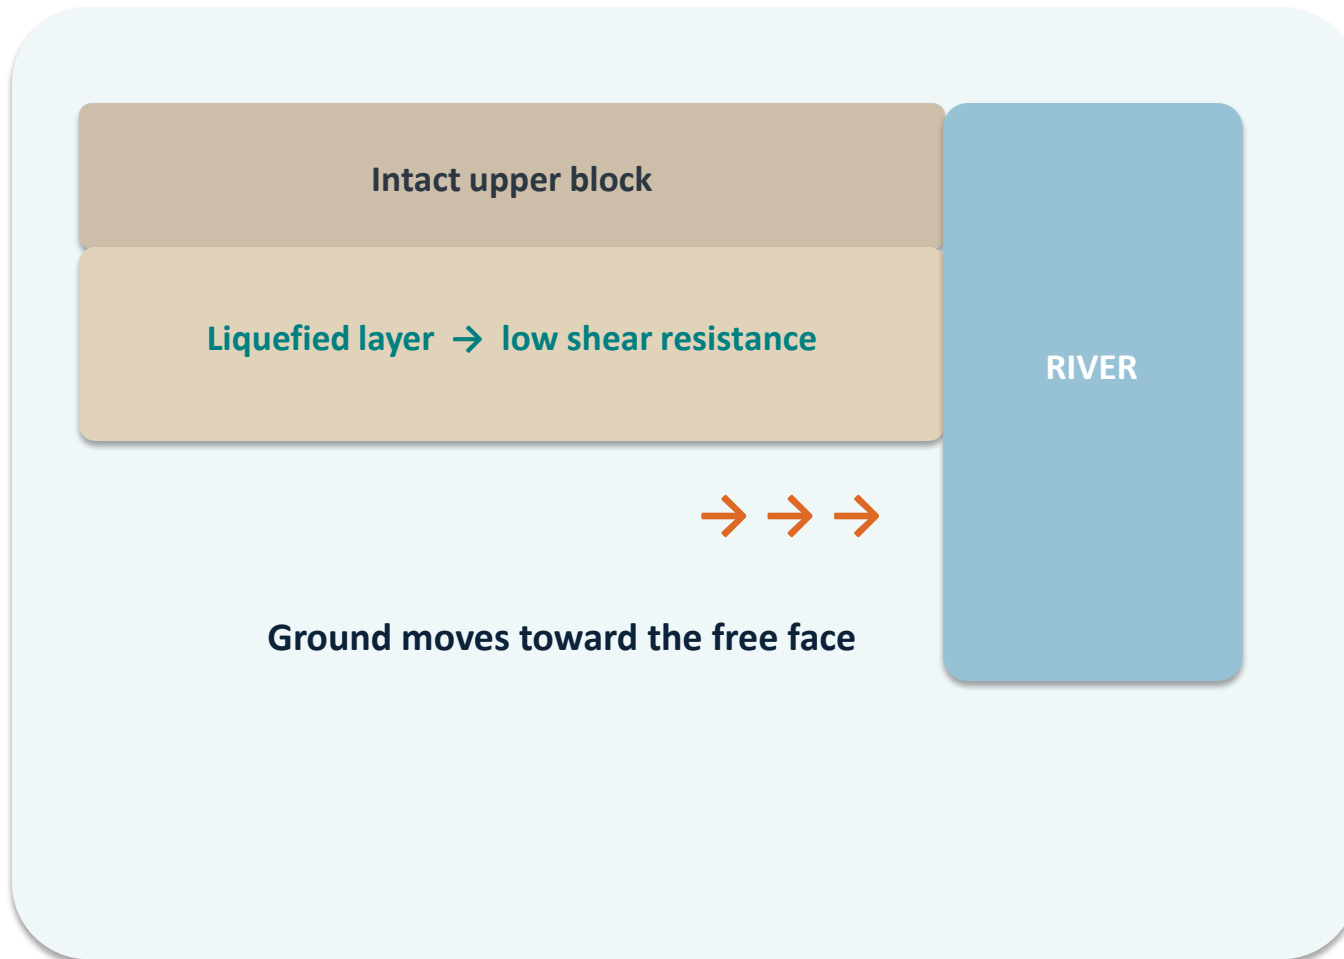
## Hazard 2 — Liquefaction-induced lateral spreading

### Typical consequences

- Riverbank and waterfront deformation.
- Lateral displacement of roads, embankments and quay structures.
- Tensile cracking and differential movement across foundations.
- High relevance to ports, bridges and riverside infrastructure.

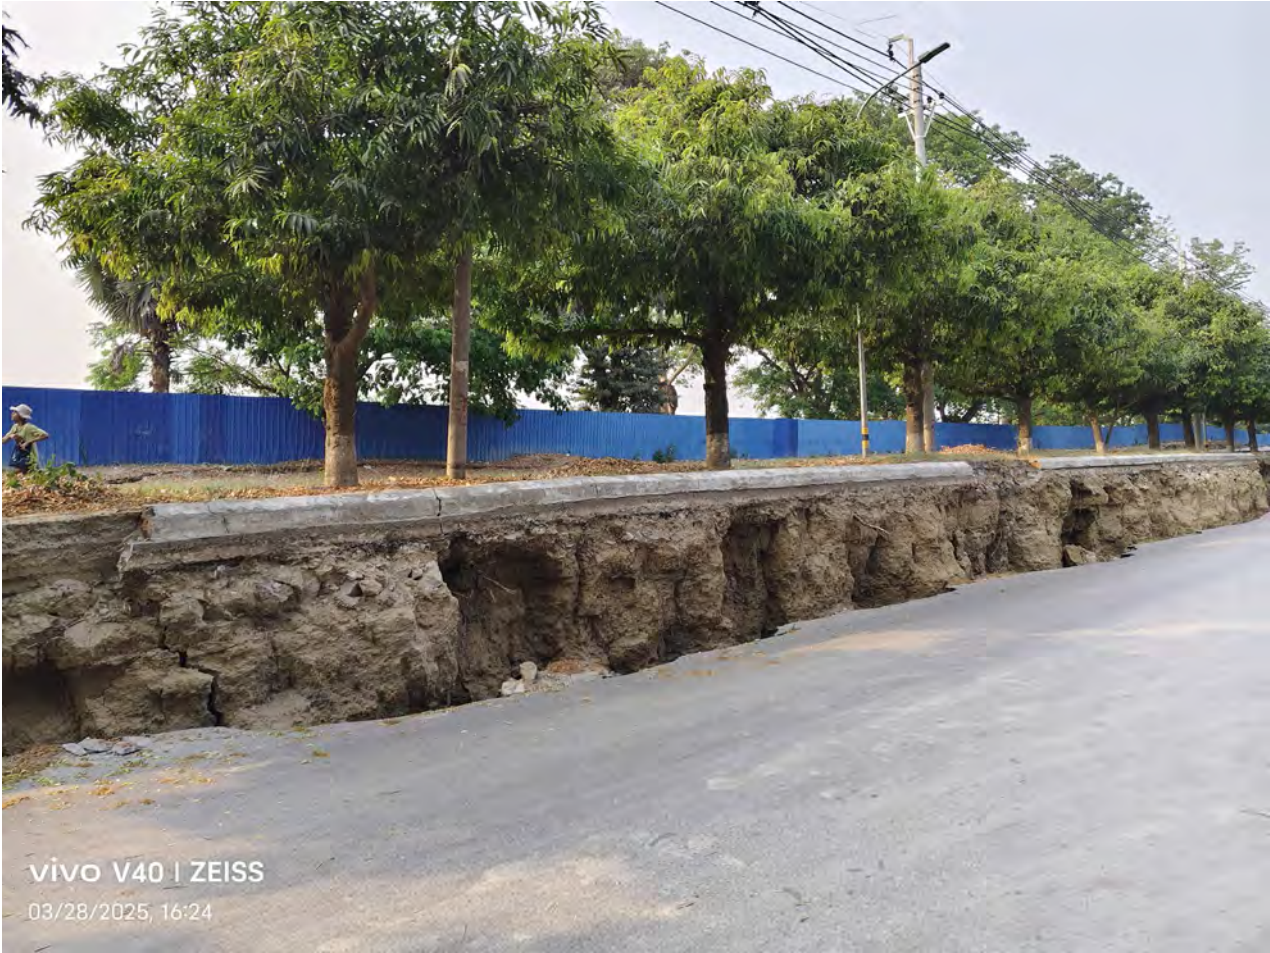
# Hazard 3 — Surface rupture, fissures and ground deformation

| <b>Tectonic</b> | Direct fault displacement or distributed deformation. |
| <b>Liquefaction</b> | Ejecta, settlement, fissures and lateral spreading. |
| <b>Differential settlement</b> | Post-liquefaction reconsolidation or variable ground response. |
| <b>Structural</b> | Cracking caused by building deformation — a different diagnostic pathway. |
| <b>Field lesson</b> | <b>Map geometry + location + soil context before assigning cause.</b> |

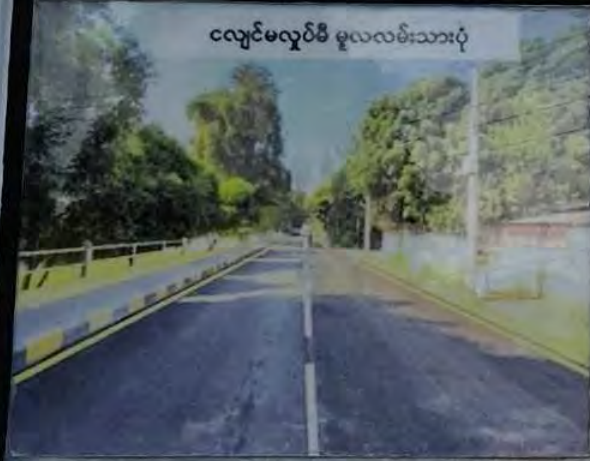
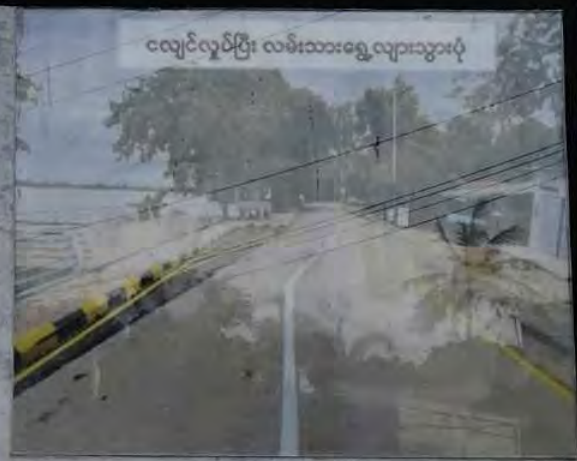
၂၀၂၅ခုနှစ်၊ မတ်လ ၂၈ရက်နေ့၊ ၁၂:၅၁မိနစ်၊ ၀၂၀က္ကန့်အချိန်၌  
မန္တလေးလျှင်ကြီးလှုပ်ခတ်မှုကြောင့် စစ်ကိုင်းမြို့၊ ကမ်းနားလမ်း၏  
လမ်းသား တောင်ဘက်သို့ ၁၂ပေခန့် ရွေ့လျားသွားပါသည်။

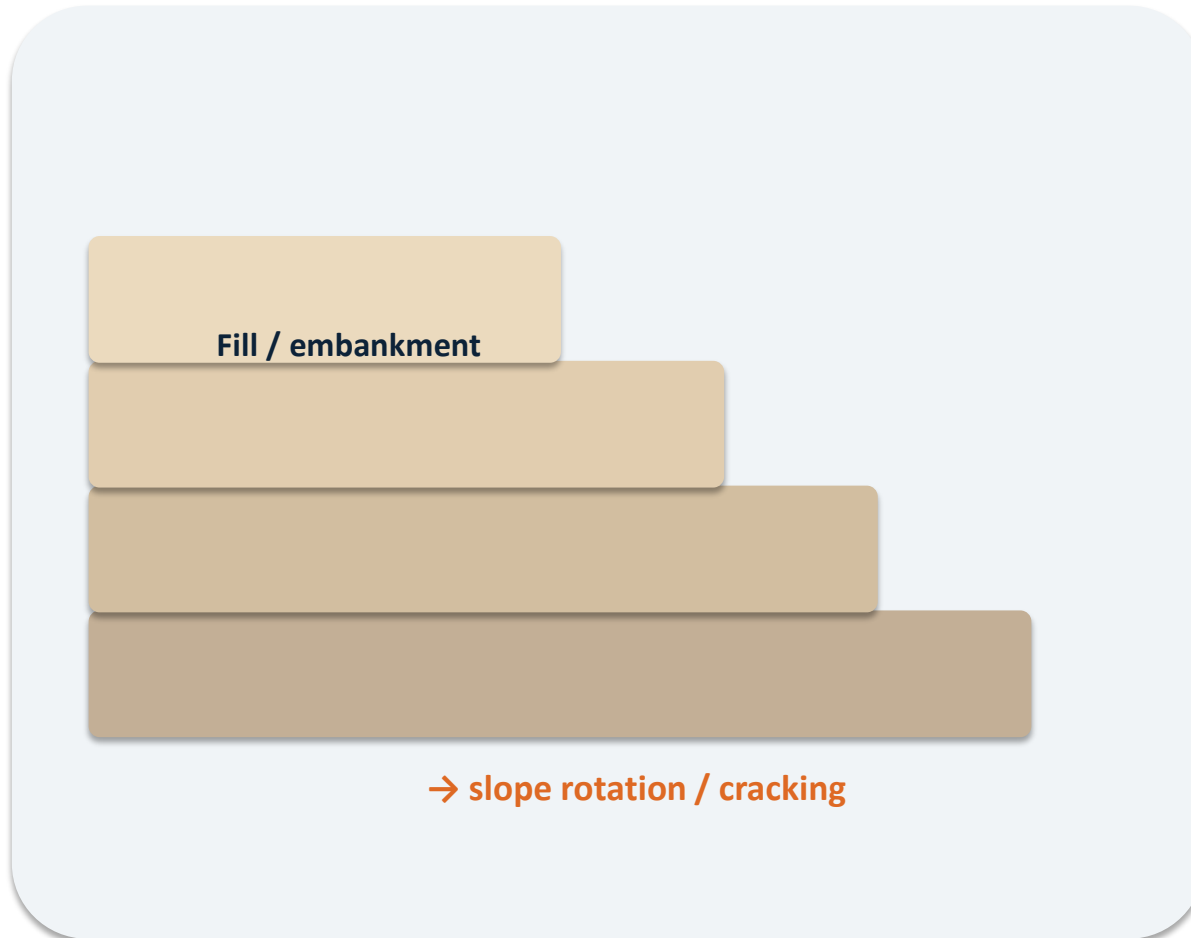
## Hazard 4 — Slopes, embankments and localized failures

### Failure triggers

- Poorly compacted or heterogeneous fill.
- Loss of strength or support in saturated layers.
- Cracking and slope rotation under strong cyclic loading.
- Road and bridge approaches require explicit geotechnical checks.

**Design the earth structure for movement — not only for static capacity.**

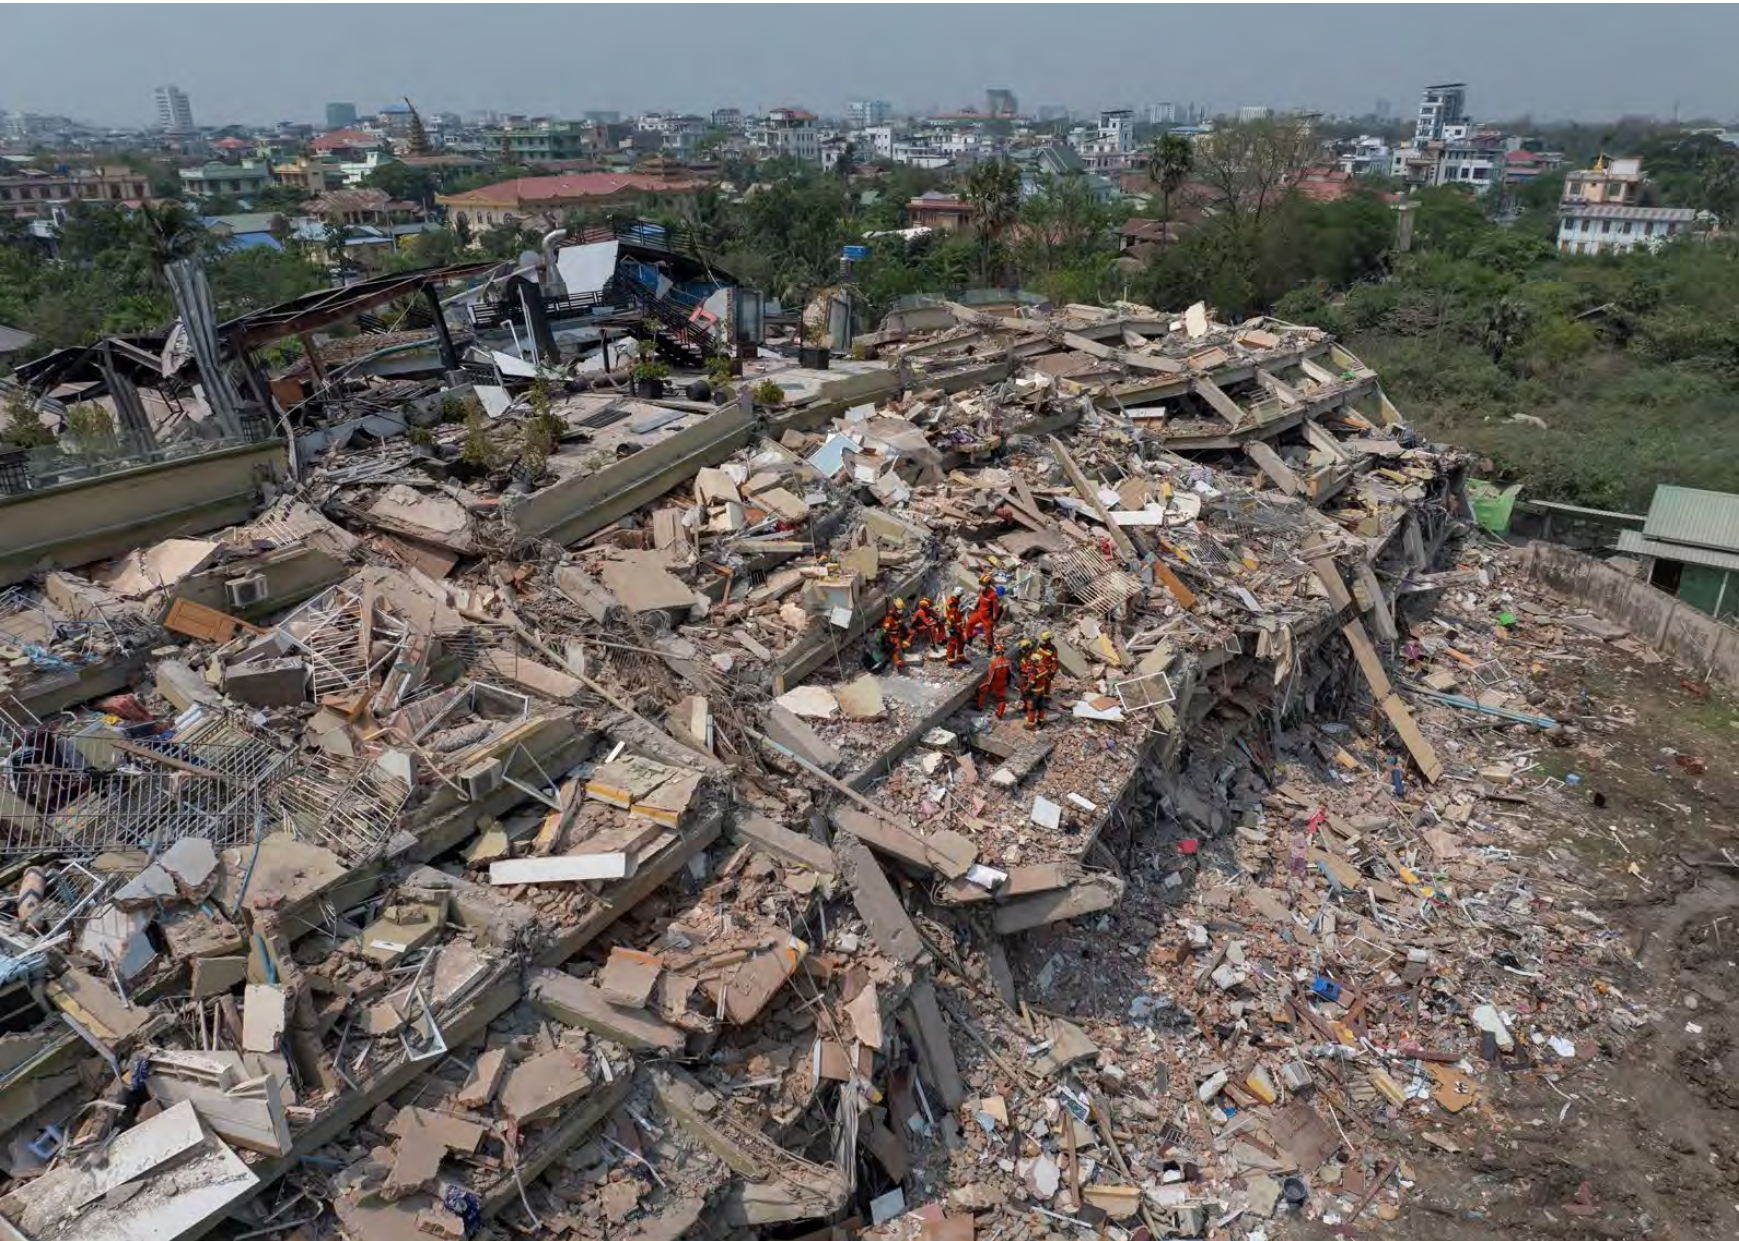
A total of 206 people died in the collapse of the 11-story **Sky Villa condominium** during the devastating **7.7-magnitude Mandalay earthquake**.

The Myanmar Fire Services Department concluded a grueling months-long search-and-rescue operation at the site on September 15, 2025, ultimately pulling **52 survivors** from the rubble alongside the 206 recovered bodies.

Legal court documents and state media later adjusted the final count to **207 bodies** recovered from the complex, which housed over 400 residents.

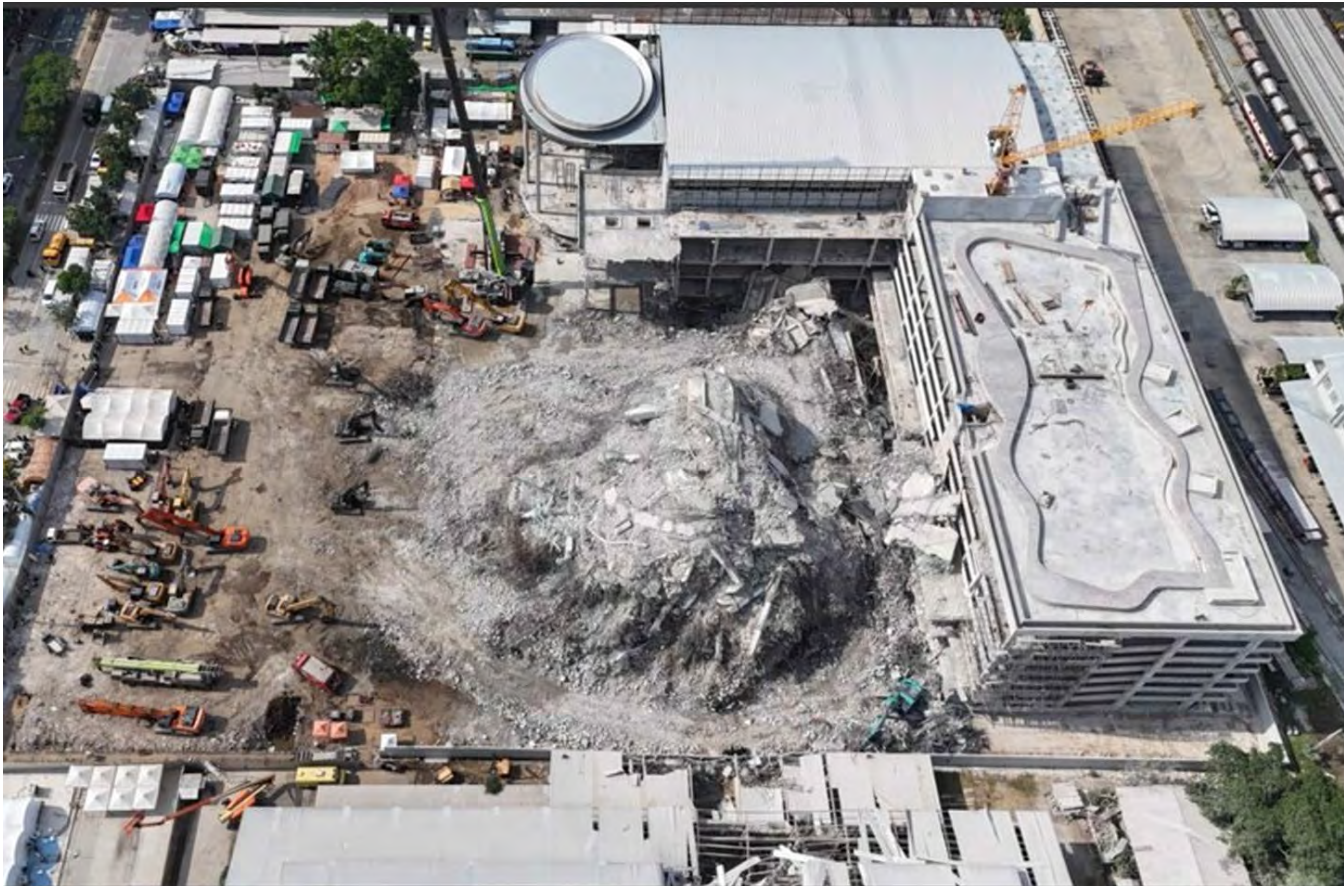
## Bangkok case

The 28 March 2025 earthquake caused the collapse of a high-rise building under construction in Bangkok. Later investigations reported design and construction deficiencies; the earthquake and local ground conditions were part of the wider context.
