### A Case Study on the Extreme Flood Affected Minmyin Dam

Due to an Extreme Flood, Dam Overtopping Happened on

18 July 2015 but Minmyin Dam was Safe.

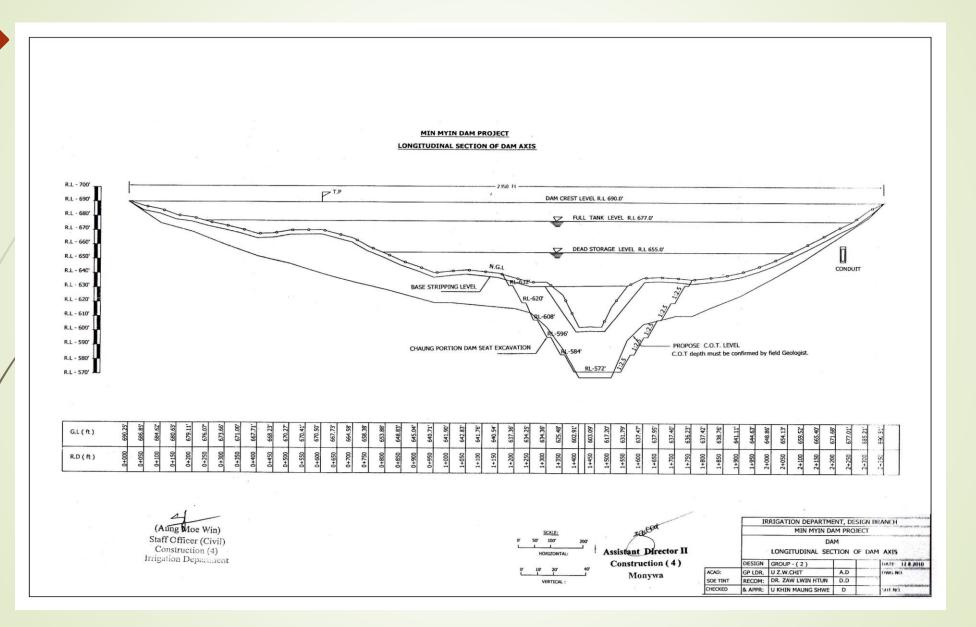
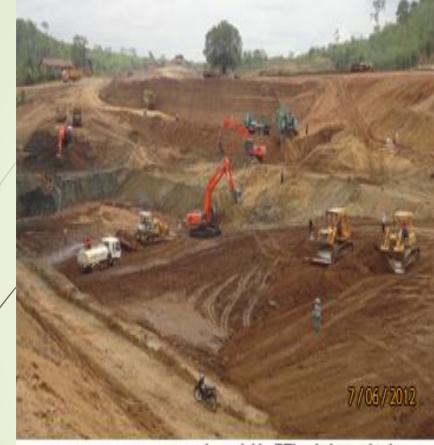
#### **Removal of Soft Soil in Chaung Section**

- To improve Bearing Capacity
- To avoid arching and uneven settlement at the Chaung section

RD- (1300) မှ RD- (1500) အတွင်း ချောင်းပိုင်းမြေကြီးလုပ်ငန်း ဆောင်ရွက်နေပုံ

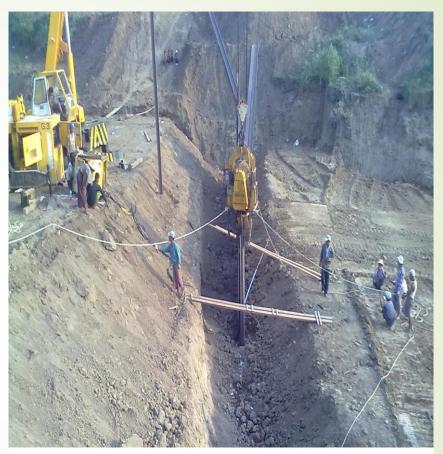
#### **Driving Sheet Pile**

Steel Sheet Pile ရိုက်ခြင်းလုပ်ငန်းဆောင်ရွက်နေပုံ

- To retain earth for excavation in Chaung section
- for curtailment of seepage from upstream of Chaung

A single sheet pile line was driven 75 ft. from upstream toe of dam.

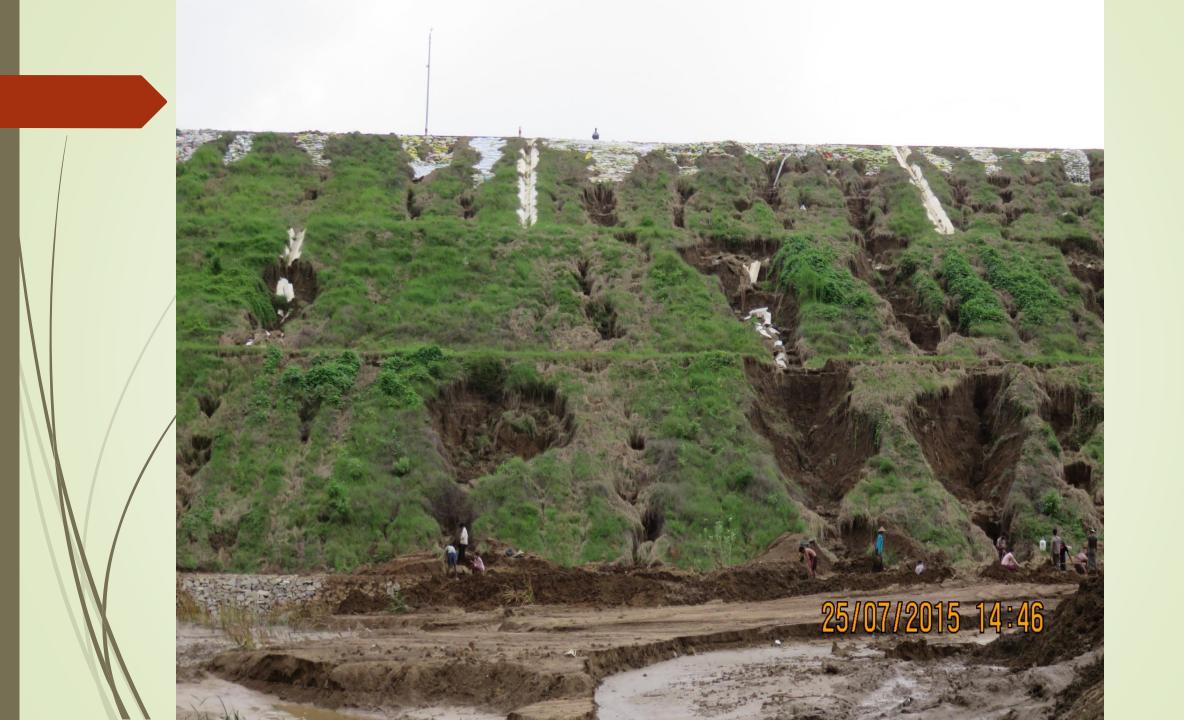
#### Dam Crest Erosion

Dam D/S Face Erosion

Duration of dam overtopping from (08:00 to 13:00) on 18.7.2015 = 5 h Maximum water level recorded on (18.7.2015, 09:20), R.L = 692.3 ft.Flood water level over dam parapet,  $H_2 = 692.3 - 692.0 = 0.3 \text{ ft.}$ Crest of parapet = 692.0 ft.

- Scours at the toe of the parapet,
- Gullies at R.D.800 ft., 1,200 ft. and 1,600 ft. on the dam downstream face,
- (9) nos. of slope drains were damaged,
- Crest drain was damaged at R.D 1,600 ft. and 2,200 ft.,
  - 150 ft. wide slip of dam toe at R.D. 1,200 ft. due to toe drain scour,
- Eroded materials deposited on rock toe,
- No differential settlement was observed,
- No bulging was observed on dam downstream face,
- Spillway under floods seemed in good condition.

- Scour at the toe of parapet is due to insufficient compaction in kankar laying,
- Slip at the downstream dam toe must be filled promptly,
- Parapet is excluded in dam height consideration, but 2.0 ft. parapet rendered an absorption of flood in this incident though some leakage from gaps between parapets,

After Flood, all the damage parts were removed and **dam filling** was made on the downstream dam slope.
