# GEOTECHNICAL HAZARDS IN MYANMAR

## Lessons from the 2025 Mw 7.7 Mandalay Earthquake

From observed ground failure to resilient ASEAN practice

**Engr. Prof: Dr. Hla Myo Aung, P.E**

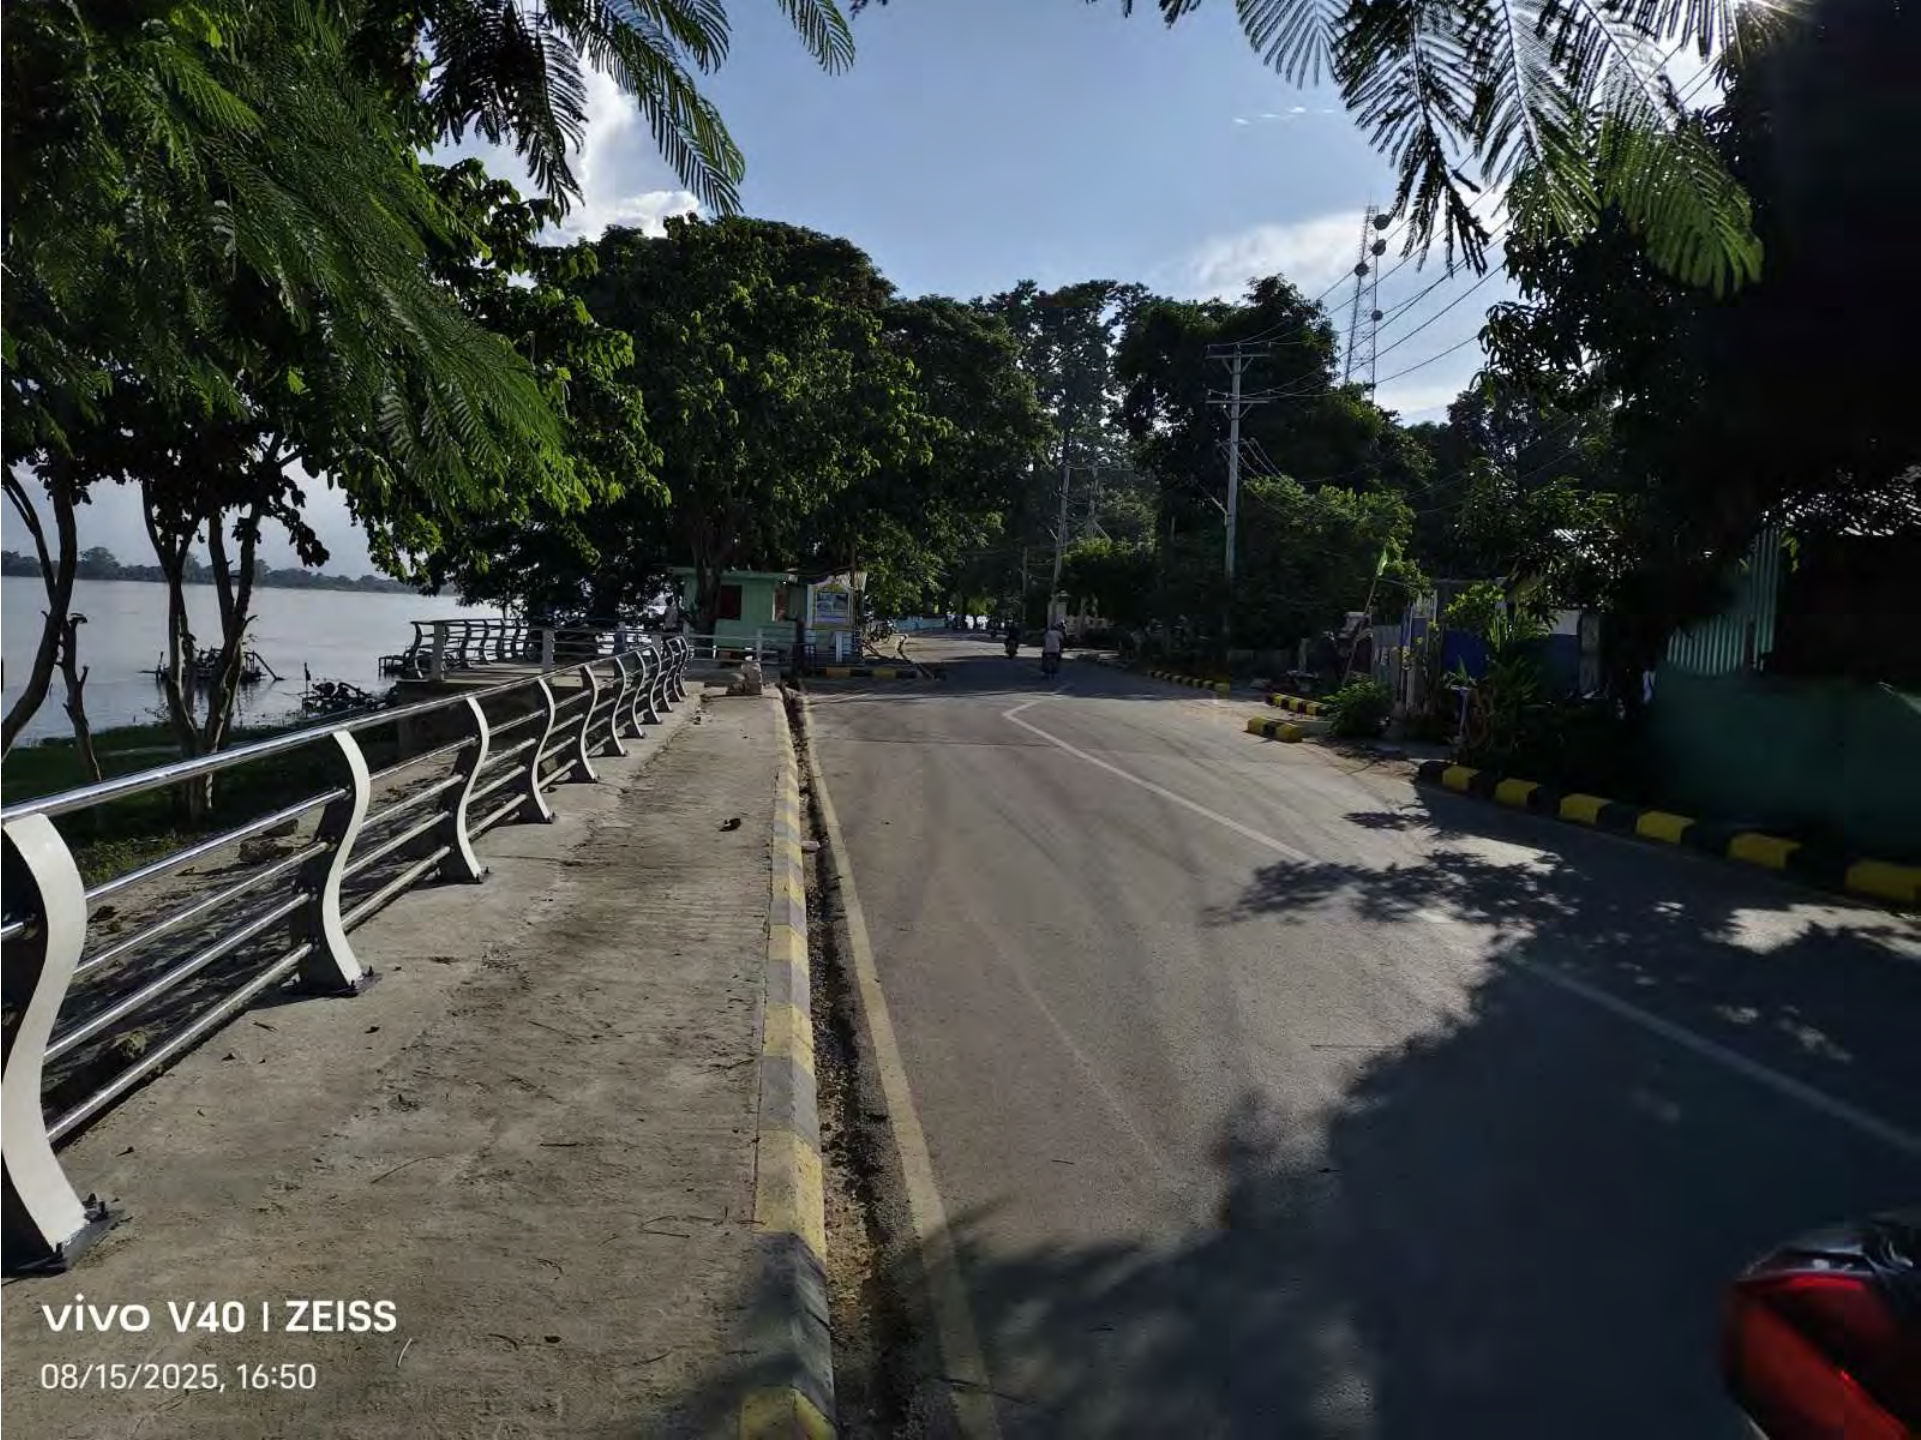
၂၀၂၅ခုနှစ်၊ မတ်လ ၂၈ရက်နေ့၊ ၁၂:၅၁မိနစ်၊ ၀၂၀က္ကန့်အချိန်၌  
မန္တလေးလျှင်ကြီးလှုပ်ခတ်မှုကြောင့် စစ်ကိုင်းမြို့၊ ကမ်းနားလမ်း၏  
လမ်းသား တောင်ဘက်သို့ ၁၂ပေခန့် ရွေ့လျားသွားပါသည်။

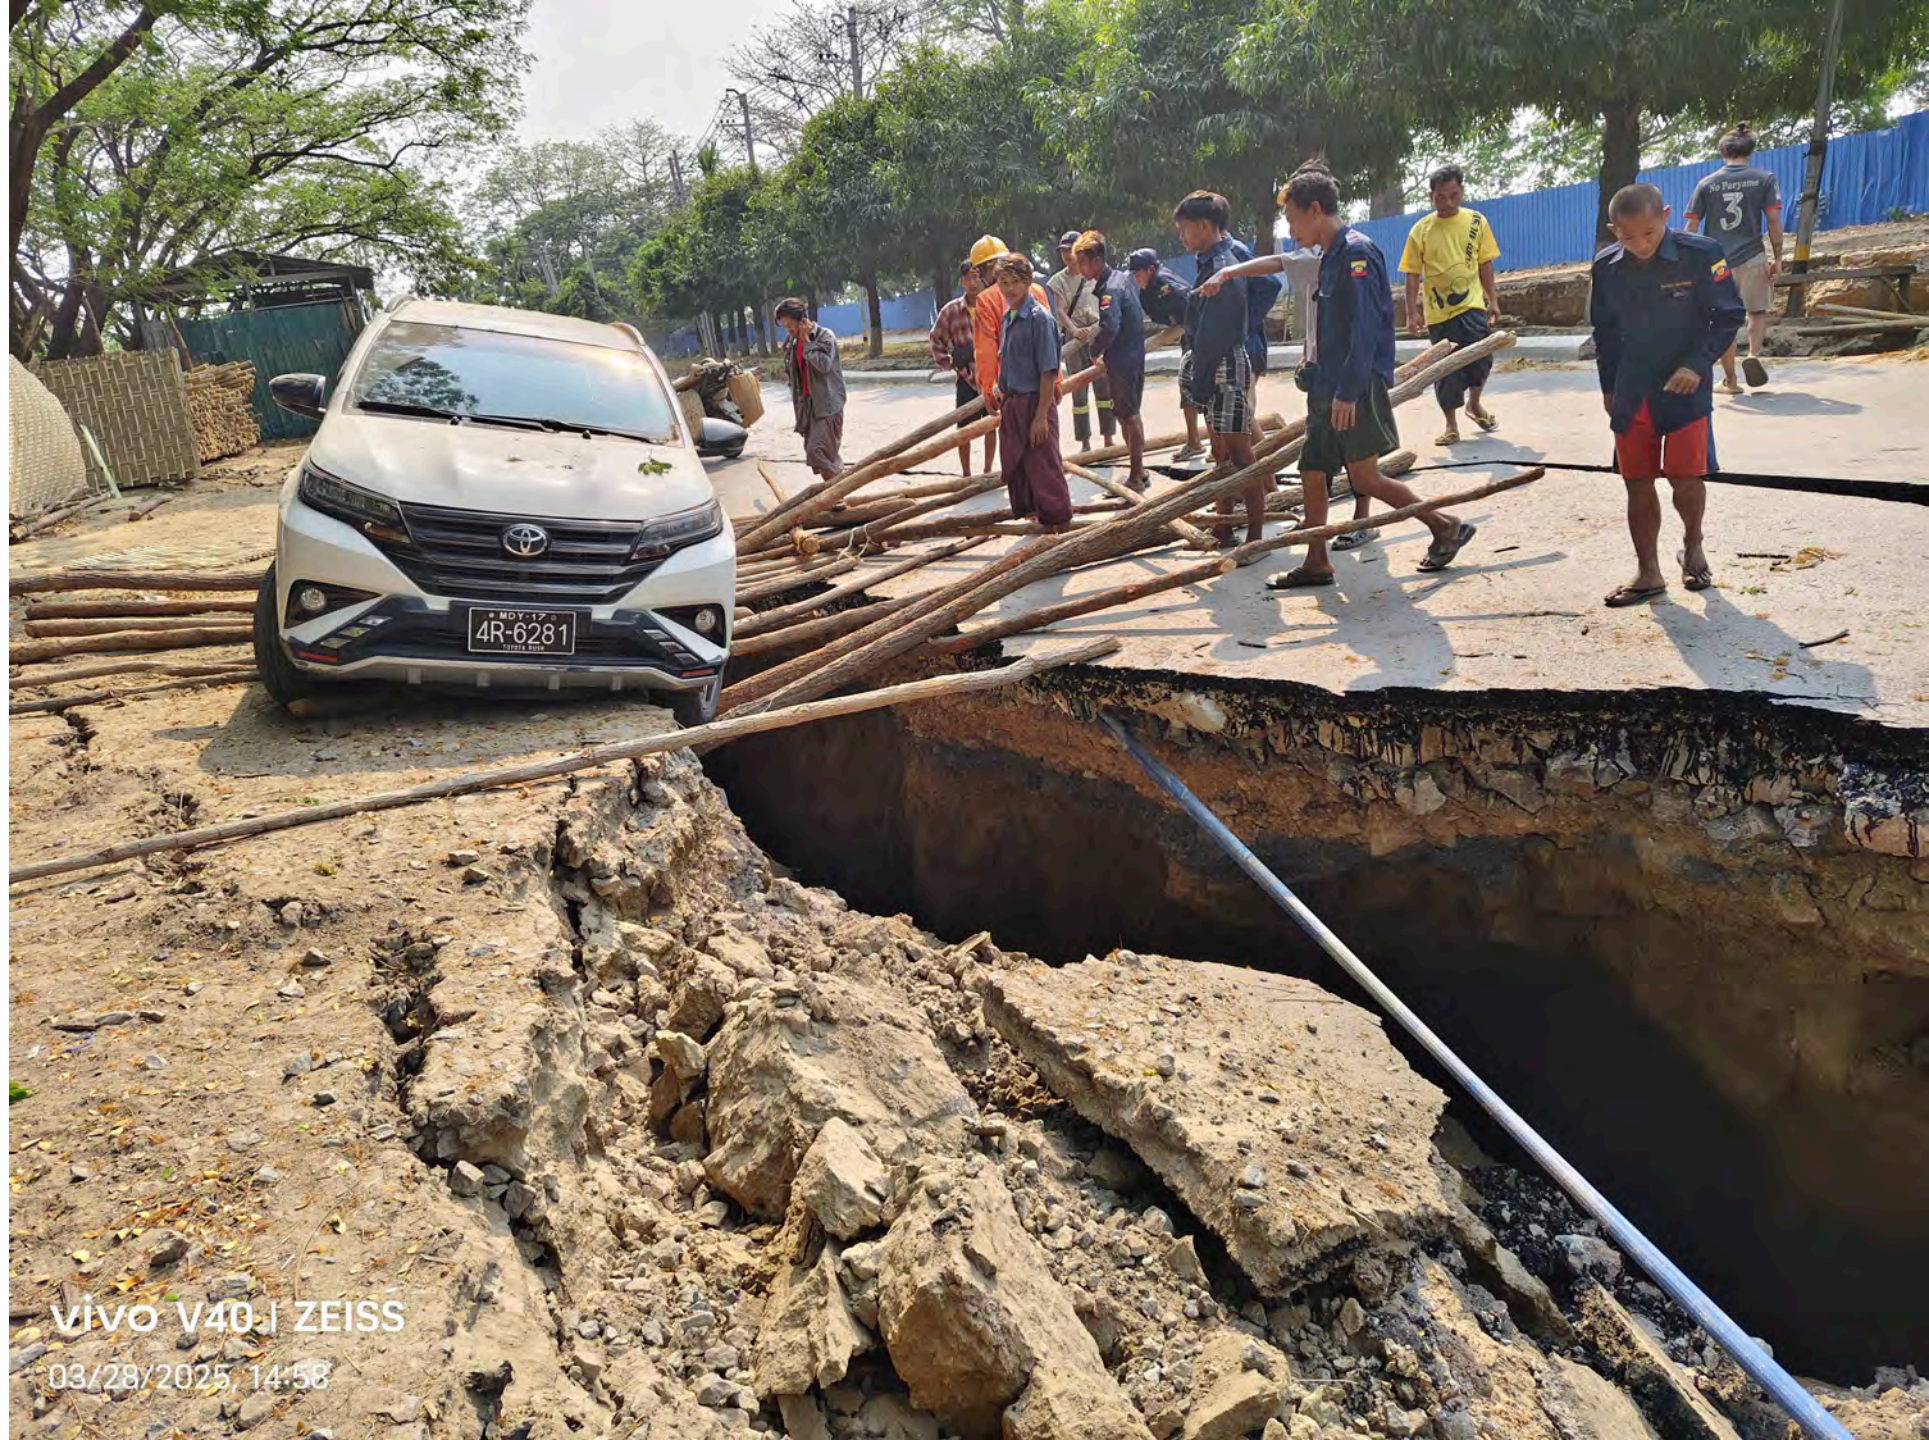
- Inadequate Site Characterization: Standard Penetration Tests (SPT) and shear wave velocity profiling were missing in legacy designs.
- Differential Settlement: Unequal foundation sinking in low-to-mid rise residential buildings due to uneven liquefiable layers.
- Embankment Slumping: Poorly compacted, unreinforced approach embankments suffered severe slope rotation and cracking.
- Neglected Soil-Structure Interaction (SSI): Structural designs lacked proper consideration of altered flexible foundation dynamics.
